Manhole Inspection Summary

Manhole # S63I__018MH

Insp Date: **5/14/08 1:02 PM**

Location Address: **603 Umbra St.**

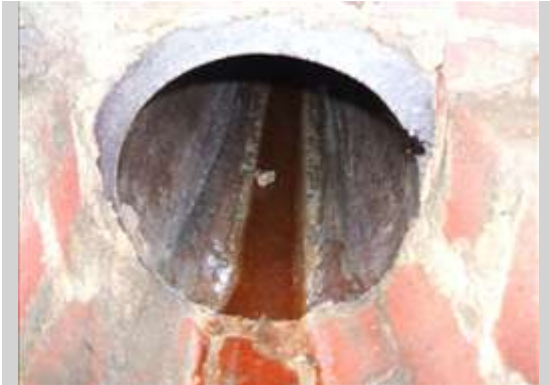
12 O'Clock Outflow

8 in. Circular Gravity Sewer
Pipe Out @ 12 O'Clock

Pipe Height: **8.4** (in.) Rod Only

Pipe Material: **Clay** ☐ Pipe Lined

Invert Depth: **8.30** (ft.) Flow Characteristics: **Slow**

Infiltration: **None** Pipe Seal Cond: **Sound**

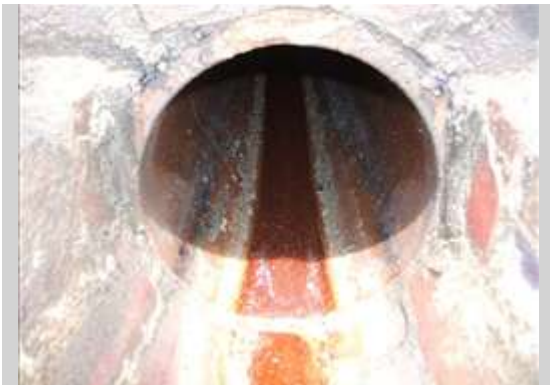
6 O'Clock Inflow

8 in. Circular Gravity Sewer
Pipe In @ 6 O'Clock

Pipe Height: **8.4** (in.) Rod Only

Pipe Material: **Clay** ☐ Pipe Lined

Infiltration: **None** Pipe Seal Cond: **Sound**
